**Flood Control Project Maintenance
Levee Inspections**

Fall 2016 Levee Maintenance Deficiency Summary Report

Sacramento River Basin

NA0001	Overall LMA Rating	Total LMA Miles						
American River Flood Control District	A	34.47						
Rated Item	Maintenance Deficiency				Enforcement		Design & System Obsolescence	
	M Miles	U Miles	M + 4U Miles	Threshold %	M Miles	U Miles	M Miles	U Miles
<i>Earthen Levee</i>								
Vegetation	0.05		0.05	0.15%	0.73	0.38		
Encroachments					1.07	3.34		
Animal Control	0.02		0.02	0.06%				
Slope Stability	0.08		0.08	0.23%				
<i>Supplemental</i>								
2015 USACE Erosion Survey, DRAFT	0.04		0.04	0.12%				
DWR UCIP Field Study					0.96	0.07		
<i>LMA Totals:</i>	0.19	0.00	0.19	0.55%	2.76	3.79	0.00	0.00
Unit No. 01 Arcade Creek LB	Overall Unit Rating	Total Unit Miles						
NA0001	A	2.08						
Rated Item	Maintenance Deficiency				Enforcement		Design & System Obsolescence	
	M Miles	U Miles	M + 4U Miles	Threshold %	M Miles	U Miles	M Miles	U Miles
<i>Earthen Levee</i>								
Vegetation	0.01		0.01	0.48%	0.04	0.03		
Encroachments					0.30	0.27

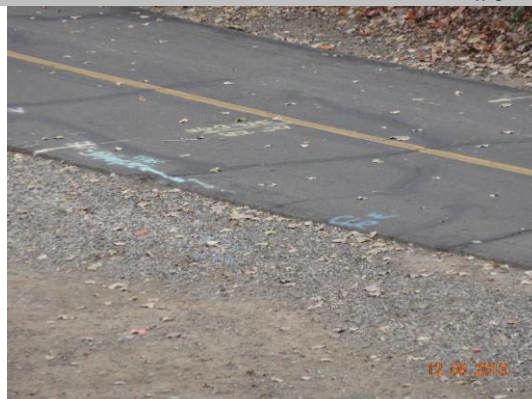
Photo 2 of 2 : UCIP_FA_2016_50049_53390.jpg

Comment Code					
Inspector Comment					
FS_ID:50049 DS_ID:24648 EP_NO: 911 Repair Type: Non-Urgent Crossing Status: Found UCIP Comments: 8/11/2016 Markers found on WS. No markers found on LS. Crossing has been downgraded from Urgent to Non-Urgent, pipe has been marked on WS only. (DWR UCIP - omagana)2/6/2015 Permit information was entered and crossing description updated. (DWR UCIP - omagana)12/3/13 Need to contact owner to determine status of crossing. Markers missing. (DWR UCIP - omagana) FIELD_STRUCT_DESC: 12.75-inch gas line through the levee at unknown depth. Markers found on the waterside (WS) approximately 192 feet and 410 feet from levee crown. No markers found on landside (LS). (line installed under Permit No. 911, 1943 - Pacific Gas and Electric Company [PG&E]) FS Date: 8/11/2016

Underground service alert (USA) approximate alignment for 12-inch gas line through levee and WS--USA markings on bike path.

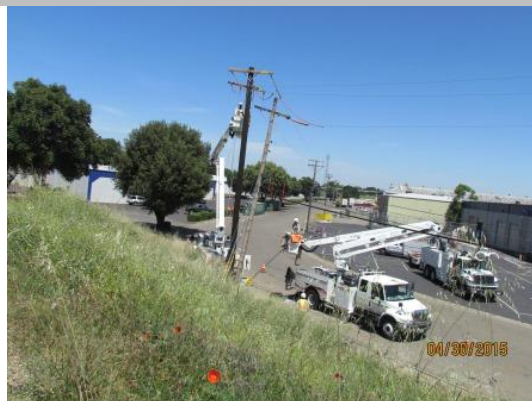
Photo 1 of 1 : FA_2016_NA0001_490_24_20160914_00005.jpg

LM Start	3.31	Rating **	M	Issue No.	24
LM End	3.31	Issue Type +	En	Location *	LS
Category	Earthen Levee			GPS Latitude/Longitude	
				Start	End
Item	Encroachments			38.600958 °	38.600958 °
				-121.471618 °	-121.471618 °
DWR ID	DWR_NA0001_03_s_2015_24				
Comment Code					
PO : Pole					
Inspector Comment					
SMUD replacing old pole at the landside toe of the levee. Pole line does not appear to be permitted.

View of a new pole installed at the landside levee toe.

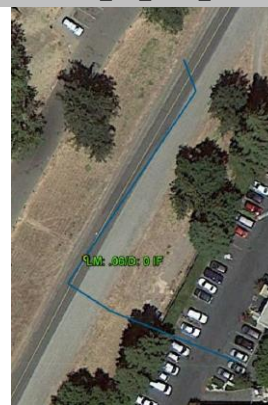
Photo 1 of 2 : UCIP_FA_2016_29003_53405.jpg

LM Start	0.06	Rating **	M	Issue No.	757
LM End	0.06	Issue Type +	En	Location *	LS
Category	Supplemental			GPS Latitude/Longitude	
				Start	End
Item	DWR UCIP Field Study			38.597198 °	38.597198 °
				-121.506532 °	-121.506532 °
DWR ID					
Comment Code					
Inspector Comment					
FS_ID:29003 DS_ID:24344 EP_NO: N/A Repair Type: Non-Urgent Crossing Status: Indicator Found UCIP Comments: Metal boxes located on landward side could be associated with utility -- unable to confirm. Will need to contact owner. FIELD_STRUCT_DESC: Electrical conduit through the levee at unknown depth. FS Date: 12/19/2013

Approximate alignment provided by the City of Sacramento for 2 inch line. Point labelled in green is field verified location where signs of crossing exist.

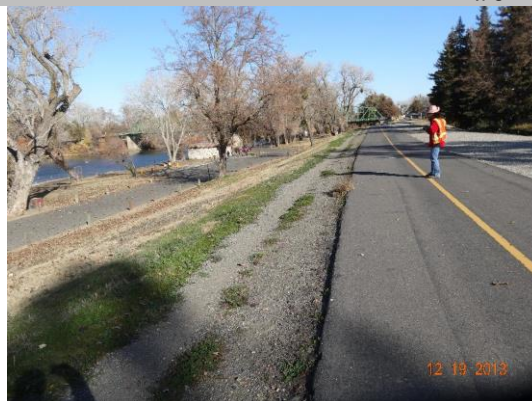
Photo 2 of 2 : UCIP_FA_2016_29003_53404.jpg

LM Start	0.06	Rating **	M	Issue No.	757 (cont)	
LM End	0.06	Issue Type +	En	Location *	LS	
Category	Supplemental			GPS Latitude/Longitude		
				Start		End
Item	DWR UCIP Field Study			38.597198 °		38.597198 °
				-121.506532 °		-121.506532 °
DWR ID						
Comment Code						
Inspector Comment						
FS_ID:29003 DS_ID:24344 EP_NO: N/A Repair Type: Non-Urgent Crossing Status: Indicator Found UCIP Comments: Metal boxes located on landward side could be associated with utility -- unable to confirm. Will need to contact owner. FIELD_STRUCT_DESC: Electrical conduit through the levee at unknown depth. FS Date: 12/19/2013

Overview of levee crown and waterward side.

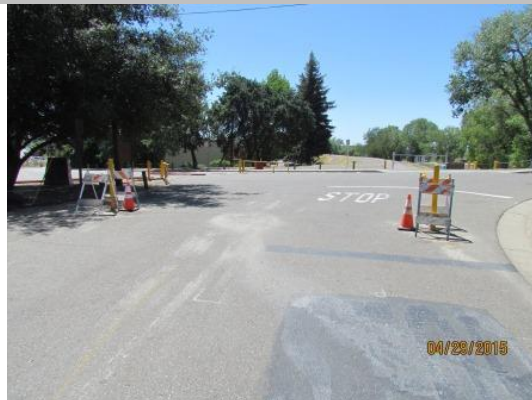
Photo 1 of 1 : FA_2016_NA0001_55_242_20160914_00188.jpg

LM Start	0.20	Rating **	A/W	Issue No.	242
LM End	0.20	Issue Type +	En	Location *	CR
Category	Earthen Levee			GPS Latitude/Longitude	
				Start	End
Item	Encroachments			38.598832 °	38.598832 °
				-121.504984 °	-121.504984 °
DWR ID	DWR_NA0001_04_s_2015_242				
Comment Code					
FE : Fence					
Inspector Comment					
County has obtained a permit from CVFPB 19069 to install gates.

View of the gate installation in progress on the levee crown.

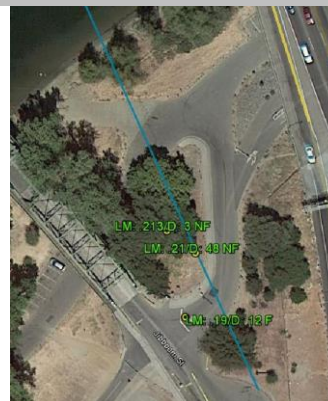
Photo 1 of 1 : UCIP_FA_2016_29006_53414.jpg

LM Start	0.21	Rating **	M	Issue No.	758
LM End	0.21	Issue Type +	En	Location *	CR
Category	Supplemental			GPS Latitude/Longitude	
				Start	End
Item	DWR UCIP Field Study			38.598982 °	38.598982 °
				-121.505045 °	-121.505045 °
DWR ID					
Comment Code					
Inspector Comment					
FS_ID:29006 DS_ID:24435 EP_NO: 17171 Repair Type: Non-Urgent Crossing Status: Not Found UCIP Comments: Unable to find any indications that crossing is still active. Will need to contact owner to determine status of crossing. FIELD_STRUCT_DESC: 48-inch steel water line through the levee, approximately 32.0 feet below the crown. Siphon and blowoff valves in concrete riser on the landside (LS). (Permit No. 17171-2001) FS Date: 12/19/2013

Approximate alignment provided by the City of Sacramento--crossing not found during field visit.

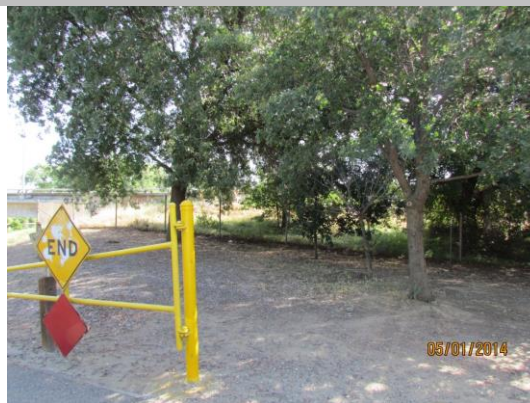
Photo 1 of 1 : FA_2016_NA0001_55_177_20160914_00154.jpg

LM Start	0.21	Rating **	M	Issue No.	177
LM End	0.21	Issue Type +	En	Location *	CR
Category	Earthen Levee			GPS Latitude/Longitude	
				Start	End
Item	Vegetation			38.598980 °	38.598980 °
				-121.504773 °	-121.504773 °
DWR ID	DWR_NA0001_04_s_2012_177				
Comment Code					
V6 : Landscaping					
Inspector Comment					
Landscaping on levee crown at overpass.

View of the landscaping on the levee crown.

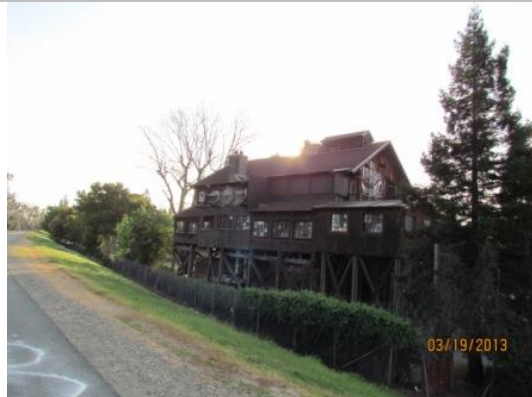
Photo 1 of 1 : FA_2016_NA0001_55_1_20160914_00001.jpg

LM Start	0.31	Rating **	M	Issue No.	1
LM End	0.45	Issue Type +	En	Location *	LS
Category	Earthen Levee			GPS Latitude/Longitude	
				Start	End
Item	Vegetation			38.599835 °	38.600769 °
				-121.503448 °	-121.501133 °
DWR ID	DWR_NA0001_04_s_2012_1				
Comment Code					
V6 : Landscaping					
Inspector Comment					
Vines and privacy fence within 10-ft of the landside toe or on the levee slope obstruct visibility and access.

View of the vines obstructing visibility.

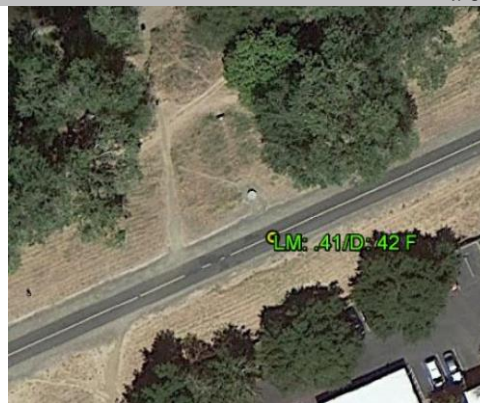
Photo 1 of 2 : UCIP_FA_2016_31249_57212.jpg

Comment Code					
Inspector Comment					
FS_ID:31249					
DS_ID:24303					
EP_NO: N/A					
Repair Type: Non-Urgent					
Crossing Status: Found					
UCIP Comments: Non-functional crossing--need additional information about how crossing was abandoned.					
FIELD_STRUCT_DESC: *ABANDONED* 42-inch corrugated metal (CM) pipe through the levee, 16.5 feet below the crown. Gravel filled with both ends welded shut. Flap gate on the waterside (WS) end. Slide gate in CM riser and splash board drain structure on the landside (LS). (USACE-1955). This entry matches the Drainage or Irrigation Structure referenced in O&M manual (Station 10+00).					
FS Date: 12/19/2013

Overview of crossing location.

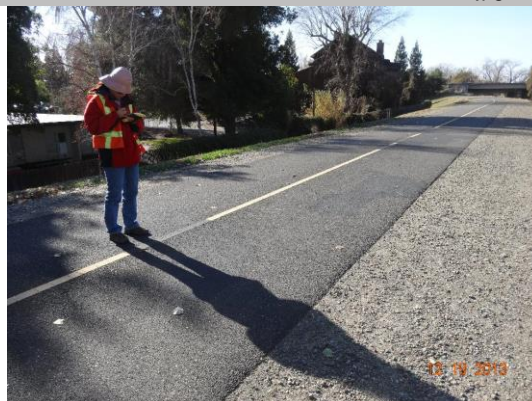
Photo 2 of 2 : UCIP_FA_2016_31249_57209.jpg

Item	DWR UCIP Field Study			38.600436 °		38.600436 °
				-121.502058 °		-121.502058 °
DWR ID						
Comment Code						
Inspector Comment						
FS_ID:31249						
DS_ID:24303						
EP_NO: N/A						
Repair Type: Non-Urgent						
Crossing Status: Found						
UCIP Comments: Non-functional crossing--need additional information about how crossing was abandoned.						
FIELD_STRUCT_DESC: *ABANDONED* 42-inch corrugated metal (CM) pipe through the levee, 16.5 feet below the crown. Gravel filled with both ends welded shut. Flap gate on the waterside (WS) end. Slide gate in CM riser and splash board drain structure on the landside (LS). (USACE-1955). This entry matches the Drainage or Irrigation Structure referenced in O&M manual (Station 10+00).						
FS Date: 12/19/2013

View of levee crown at this location.

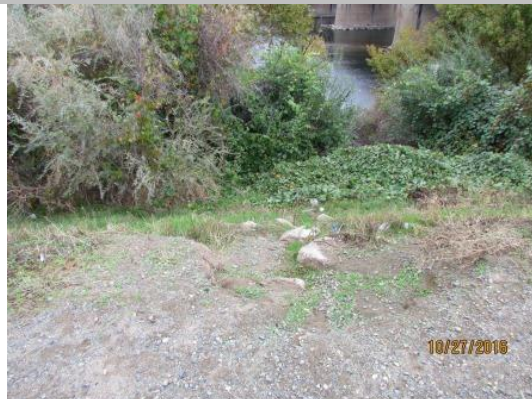
Photo 2 of 2 : FA_2016_NA0001_55_250_20161031_00258.jpg

LM Start	1.85	Rating **	A/W	Issue No.	250 (cont)	
LM End	1.85	Issue Type +	Ma	Location *	WS	
Category	Earthen Levee			GPS Latitude/Longitude		
				Start		End
Item	Slope Stability			38.596220 °		38.596220 °
				-121.477713 °		-121.477713 °
DWR ID	DWR_NA0001_04_s_2016_250					
Comment Code						
S2 : Repair the levee slope damaged by foot traffic and prevent access where possible.						
Inspector Comment

View of the footpath on the waterside levee slope, looking at the slope.

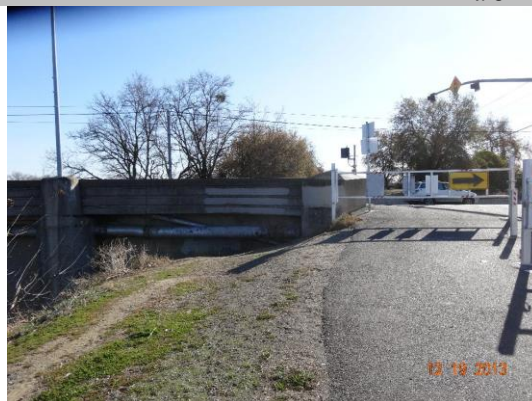
Photo 1 of 2 : UCIP_FA_2016_49935_53496.jpg

Comment Code					
Inspector Comment					
FS_ID:49935 DS_ID:24307 EP_NO: N/A Repair Type: Urgent Crossing Status: Found UCIP Comments: 8/11/2016 Crossing was classified incorrectly. Crossing is not a gas line. This crossing appears to be an abandoned sewer line. On WS, holes are present on the pipe wall and visible cracks are found on the concrete wall where pipe crosses. According to LMA, Tim Kerr and Richard Marck, this crossing could be a City line. Need to find owner and determine fate of crossing. Owner will need to coordinate with CVFPB to comply with Title 23. (DWR UCIP - omagana)12/19/2013 No markers or labels visible to indicate line is gas line--unable to confirm. (DWR UCIP - omagana) FIELD_STRUCT_DESC: *ABANDONED* 18-inch (not 20-inch as referenced in DWR levee logs) steel line of unknown type through the levee, 5 feet below the crown. The 20-inch pipe was initially referenced as a 20-inch gas line under DWR levee logs that dated back to 1956. During the 2016 inspection, the pipe was identified (field measured) as an 18-inches non-gas line. It appears that this crossing has been mis-labelled or replaced no additional information was found. [Additional Reference(s): DWR Levee Log, 1956 and 2002] FS Date: 8/11/2016

View of line exposed at the bridge.

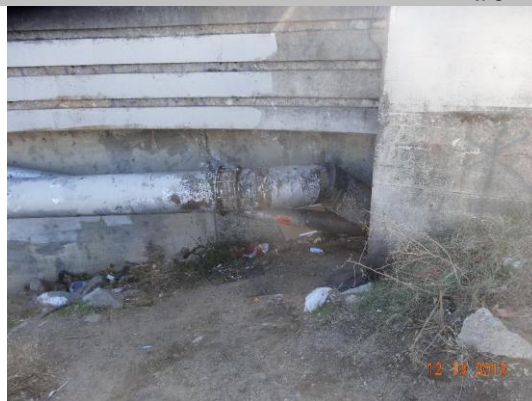
Photo 2 of 2 : UCIP_FA_2016_49935_53495.jpg

Item	DWR UCIP Field Study			38.595911 °	38.595911 °	
				-121.477485 °	-121.477485 °	
DWR ID						
Comment Code						
Inspector Comment						
FS_ID:49935 DS_ID:24307 EP_NO: N/A Repair Type: Urgent Crossing Status: Found UCIP Comments: 8/11/2016 Crossing was classified incorrectly. Crossing is not a gas line. This crossing appears to be an abandoned sewer line. On WS, holes are present on the pipe wall and visible cracks are found on the concrete wall where pipe crosses. According to LMA, Tim Kerr and Richard Marck, this crossing could be a City line. Need to find owner and determine fate of crossing. Owner will need to coordinate with CVFPB to comply with Title 23. (DWR UCIP - omagana)12/19/2013 No markers or labels visible to indicate line is gas line--unable to confirm. (DWR UCIP - omagana) FIELD_STRUCT_DESC: *ABANDONED* 18-inch (not 20-inch as referenced in DWR levee logs) steel line of unknown type through the levee, 5 feet below the crown. The 20-inch pipe was initially referenced as a 20-inch gas line under DWR levee logs that dated back to 1956. During the 2016 inspection, the pipe was identified (field measured) as an 18-inches non-gas line. It appears that this crossing has been mislabelled or replaced no additional information was found. [Additional Reference(s): DWR Levee Log, 1956 and 2002] FS Date: 8/11/2016

Two crossings visible at bridge.

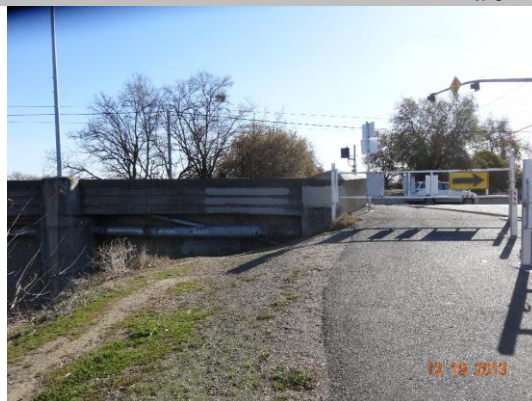
Photo 1 of 2 : UCIP_FA_2016_50050_55422.jpg

LM Start	1.88	Rating **	M	Issue No.	772
LM End	1.88	Issue Type +	En	Location *	WS
Category	Supplemental			GPS Latitude/Longitude	
				Start	End
Item	DWR UCIP Field Study			38.595911 °	38.595911 °
				-121.477485 °	-121.477485 °
DWR ID					
Comment Code					
Inspector Comment					
FS_ID:50050					
DS_ID:24528					
EP_NO: N/A					
Repair Type: Non-Urgent					
Crossing Status: Found					
UCIP Comments: 9/21/2016 According to CVFPB enforcement records.					
PG&E is working on submitting permit for gas line. (DWR UCIP - omagana)8/11/2016 gas line is clearly marked on WS. (DWR UCIP - omagana)					
FIELD_STRUCT_DESC: 10-inch steel gas main through the levee, 5 feet below the crown. PG&E label found on WS portion of exposed pipe. Contact for PG&E 1-800-743-6990 or 1-800642-2444. [Additional Reference(s): DWR Levee Log, 2002]					
FS Date: 8/11/2016

Utility lines through levee and across channel.

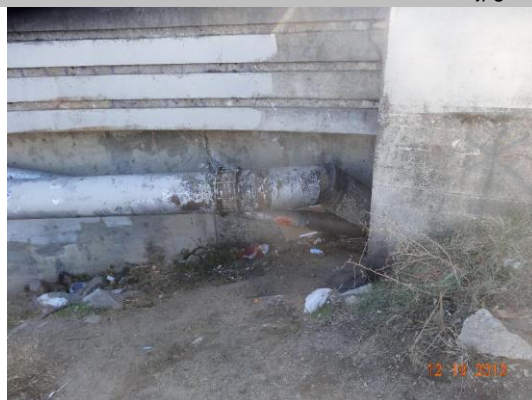
Photo 2 of 2 : UCIP_FA_2016_50050_55421.jpg

Larger line is not marked as gas line and smaller line has label indicating gas line.

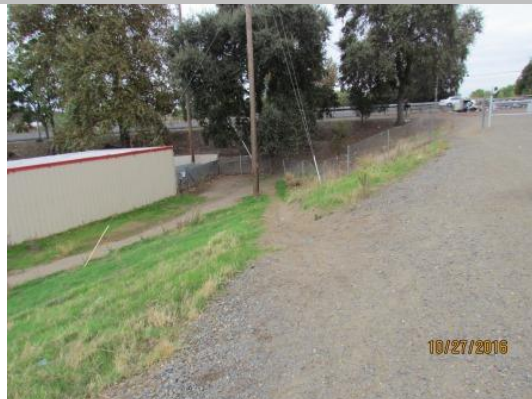
Photo 1 of 1 : FA_2016_NA0001_55_244_20161031_00256.jpg

LM Start	1.95	Rating **	A/W	Issue No.	244
LM End	1.95	Issue Type +	Ma	Location *	LS
Category	Earthen Levee			GPS Latitude/Longitude	
				Start	End
Item	Slope Stability			38.595040 °	38.595040 °
				-121.476882 °	-121.476882 °
DWR ID	DWR_NA0001_04_f_2015_244				
Comment Code					
S2 : Repair the levee slope damaged by foot traffic and prevent access where possible.					
Inspector Comment

View of the footpath on the landside levee slope.

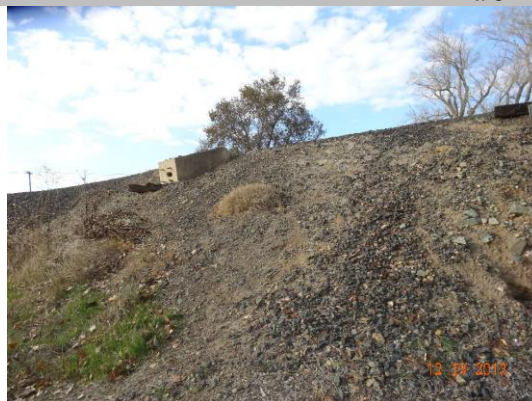
Photo 1 of 2 : UCIP_FA_2016_29927_55259.jpg

LM Start	2.25	Rating **	M	Issue No.	753
LM End	2.25	Issue Type +	En	Location *	LS
Category	Supplemental			GPS Latitude/Longitude	
				Start	End
Item	DWR UCIP Field Study			38.591923 °	38.591923 °
				-121.473744 °	-121.473744 °
DWR ID					
Comment Code					
Inspector Comment					
FS_ID:29927					
DS_ID:24310					
EP_NO: 14150					
Repair Type: Non-Urgent					
Crossing Status: Indicator Found					
UCIP Comments: unable to confirm if crossing is 4-inch steel conduit--will need to coordinate with owner.					
FIELD_STRUCT_DESC: 4-inch steel pipe conduit containing fiber optic cables through the levee, 3.5 feet below the crown. Markers on the levee shoulder. Rock revetment on the waterside (WS) slope. (Permit No. 14150-1986)					
FS Date: 12/19/2013

View of waterward slope--concrete box could be associated with conduit?

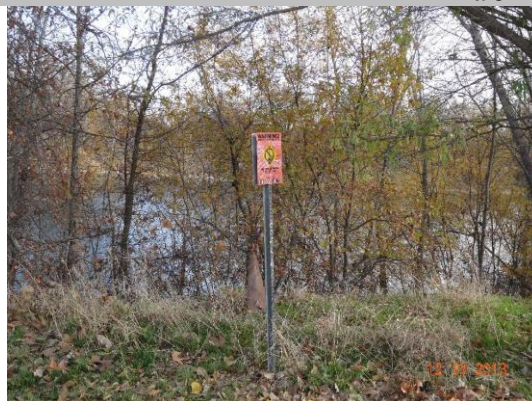
Photo 2 of 2 : UCIP_FA_2016_29927_55261.jpg

LM Start	2.25	Rating **	M	Issue No.	753 (cont)	
LM End	2.25	Issue Type +	En	Location *	LS	
Category	Supplemental			GPS Latitude/Longitude		
				Start	End	
Item	DWR UCIP Field Study			38.591923 °	38.591923 °	
				-121.473744 °	-121.473744 °	
DWR ID						
Comment Code						
Inspector Comment						
FS_ID:29927 DS_ID:24310 EP_NO: 14150 Repair Type: Non-Urgent Crossing Status: Indicator Found UCIP Comments: unable to confirm if crossing is 4-inch steel conduit--will need to coordinate with owner. FIELD_STRUCT_DESC: 4-inch steel pipe conduit containing fiber optic cables through the levee, 3.5 feet below the crown. Markers on the levee shoulder. Rock revetment on the waterside (WS) slope. (Permit No. 14150-1986) FS Date: 12/19/2013

Marker for buried fiber optic cable on waterward side.

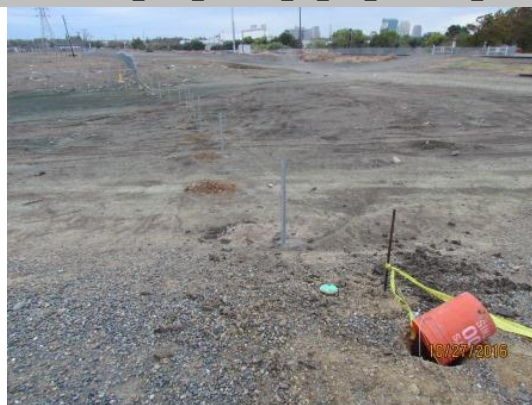
Photo 1 of 3 : FA_2016_NA0001_55_252_20161031_00252.jpg

LM Start	2.28	Rating **	U	Issue No.	252
LM End	2.28	Issue Type +	En	Location *	CR
Category	Earthen Levee			GPS Latitude/Longitude	
				Start	End
Item	Encroachments			38.591602 °	38.591602 °
				-121.473223 °	-121.473223 °
DWR ID	DWR_NA0001_04_f_2016_252				
Comment Code					
FE : Fence					
Inspector Comment					
Unauthorized fence being installed across the levee and down the landside and waterside slopes and into the floodway.

Landside view of the new fence construction across the levee crown.

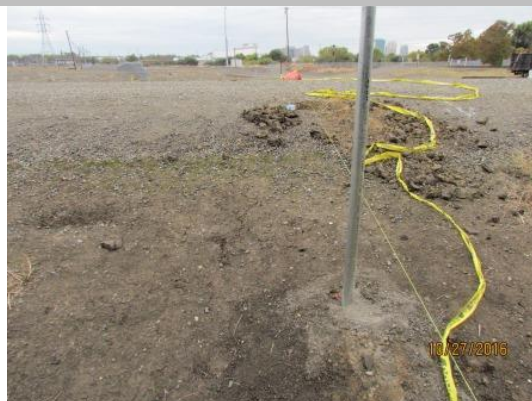
Photo 2 of 3 : FA_2016_NA0001_55_252_20161031_00254.jpg

Waterside view of the new fence construction across the levee crown.

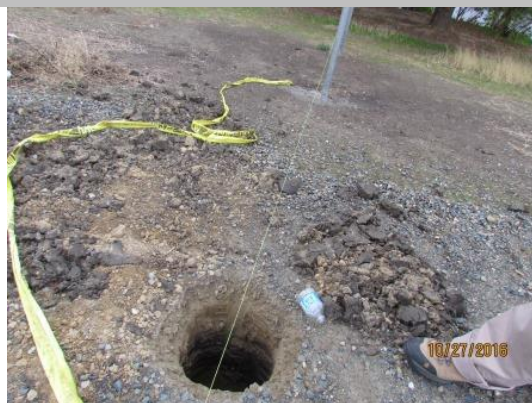
Photo 3 of 3 : FA_2016_NA0001_55_252_20161031_00255.jpg

View of the fence post hole in the levee crown.

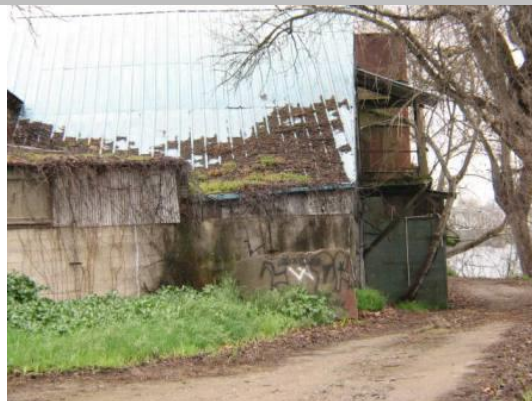
Photo 1 of 1 : FA_2016_NA0001_55_2_20160914_00002.jpg

LM Start	2.68	Rating **	U	Issue No.	2
LM End	2.68	Issue Type +	En	Location *	LS
Category	Earthen Levee			GPS Latitude/Longitude	
				Start	End
Item	Encroachments			38.588913 °	38.588913 °
				-121.467210 °	-121.467210 °
DWR ID	DWR_NA0001_04_s_2012_2				
Comment Code					
BU : Building					
Inspector Comment					
Bell Marine

03/16/2012 Structure on Bell Marine property.

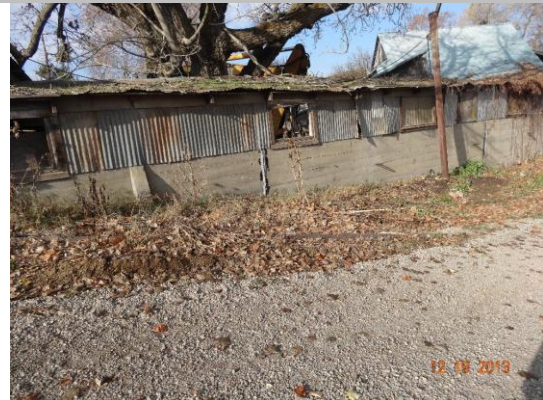
Photo 2 of 2 : UCIP_FA_2016_29944_55266.jpg

Comment Code						
Inspector Comment						
FS_ID:29944						
DS_ID:24327						
EP_NO: 3362						
Repair Type: Non-Urgent						
Crossing Status: Found						
UCIP Comments: Pipe sections abandoned on levee crown--need to contact owner to determine status of crossing.						
FIELD_STRUCT_DESC: 12-inch steel pipe through the levee. Pipe extends from a settling pond, on the left bank berm, to an existing borrow pit located in the overflow area adjacent to the right bank. The pipeline is buried through the top of the riverbanks and buried in the left bank with aggregate revetment placed on the bank. The remainder of the pipeline is exposed across the bottom of the channel and the right bank. The line is used to divert wash water return from the gravel plant to the opposite side of the river. (Permit 8146-1974)						
FS Date: 12/19/2013

View of structure located on levee crown.

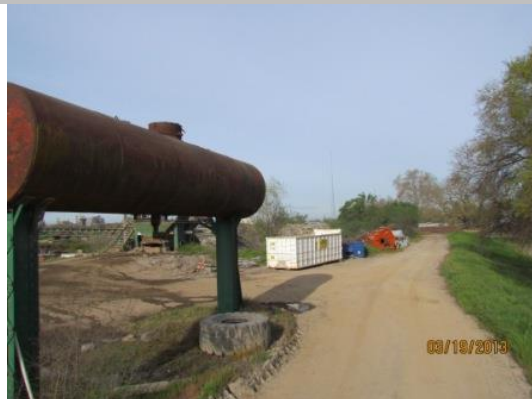
Photo 1 of 1 : FA_2016_NA0001_55_3_20160914_00003.jpg

LM Start	2.72	Rating **	M	Issue No.	3
LM End	2.86	Issue Type +	En	Location *	LS
Category	Earthen Levee			GPS Latitude/Longitude	
				Start	End
Item	Encroachments			38.587939 °	38.587299 °
				-121.466635 °	-121.464320 °
DWR ID	DWR_NA0001_04_s_2012_3				
Comment Code					
EQ : Equipment					
Inspector Comment					
Bell Marine, LMA sent a letter to property owner for the violation.

View of the debris obstructing visibility and access.

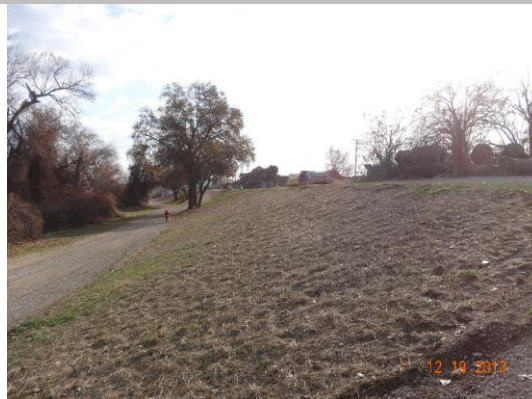
Photo 1 of 2 : UCIP_FA_2016_31444_57486.jpg

LM Start	2.77	Rating **	M	Issue No.	759
LM End	2.77	Issue Type +	En	Location *	CR
Category	Supplemental			GPS Latitude/Longitude	
				Start	End
Item	DWR UCIP Field Study			38.587629 °	38.587629 °
				-121.465905 °	-121.465905 °
DWR ID					
Comment Code					
Inspector Comment					
FS_ID:31444					
DS_ID:24805					
EP_NO: N/A					
Repair Type: Non-Urgent					
Crossing Status: Indicator Found					
UCIP Comments: No permit (unauthorized crossing)--need additional information about crossing.					
FIELD_STRUCT_DESC: Standpipe located on waterward shoulder.					
Unable to confirm pipe alignment. No permit found.					
FS Date: 12/19/2013

View of waterward slope.

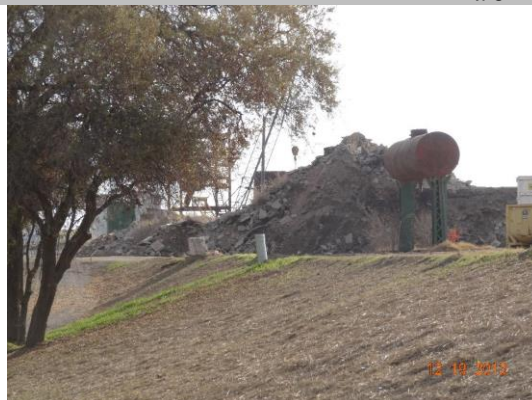
Photo 2 of 2 : UCIP_FA_2016_31444_57485.jpg

Standpipe located on waterward shoulder.

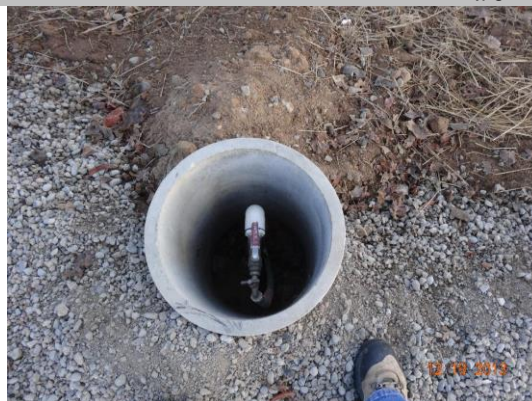
Photo 1 of 1 : UCIP_FA_2016_31445_57487.jpg

LM Start	2.82	Rating **	M	Issue No.	760
LM End	2.82	Issue Type +	En	Location *	CR
Category	Supplemental			GPS Latitude/Longitude	
				Start	End
Item	DWR UCIP Field Study			38.587438 °	38.587438 °
				-121.464989 °	-121.464989 °
DWR ID					
Comment Code					
Inspector Comment					
FS_ID:31445					
DS_ID:24806					
EP_NO: N/A					
Repair Type: Non-Urgent					
Crossing Status: Found					
UCIP Comments: No permit found (unauthorized?)--need additional information about crossing.					
FIELD_STRUCT_DESC: Standpipe located on waterside (WS) shoulder. Pipe crosses levee crown and landside (LS). Pipe used for irrigation. No Permit found.					
FS Date: 12/13/2013

Spigot located inside riser located on waterward shoulder.

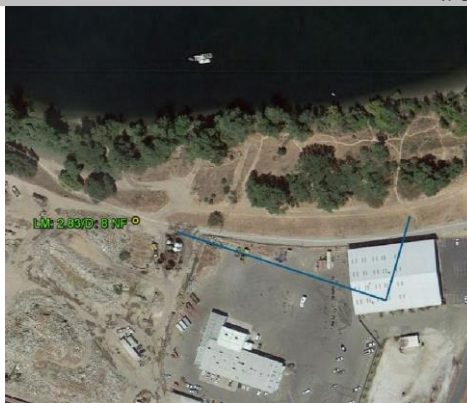
Photo 1 of 1 : UCIP_FA_2016_31253_57216.jpg

Comment Code					
Inspector Comment					
FS_ID:31253 DS_ID:24328 EP_NO: 5890 Repair Type: Non-Urgent Crossing Status: Not Found UCIP Comments: Need to contact owner to determine status of crossing--approximate alignment indicates pipe does not cross levee however records shows drain pipe crosses levee. FIELD_STRUCT_DESC: 8-inch corrugated metal (CM) drainpipe through the levee, 2.1 feet below the crown. Concrete drop inlet structure at waterside (WS) shoulder. Maintenance facilities and yard on the landside (LS). Rock revetment on WS slope. (Pemit No. 5890-1968) This entry matches the Drainage or Irrigation Structure referenced in O&M manual (Station 156+75). FS Date: 12/19/2013

Approximate alignment indicated in blue and approximate location indicated by DWR-UCIP in green label.

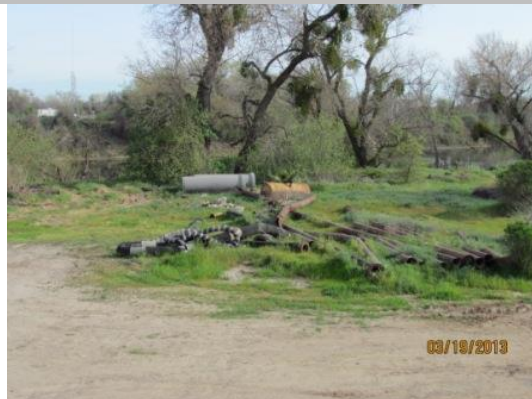
Photo 1 of 2 : FA_2016_NA0001_55_4_20160914_00004.jpg

LM Start	2.83	Rating **	M	Issue No.	4
LM End	2.83	Issue Type +	En	Location *	WS
Category	Earthen Levee			GPS Latitude/Longitude	
				Start	End
Item	Encroachments			38.587272 °	38.587272 °
				-121.464768 °	-121.464768 °
DWR ID	DWR_NA0001_04_s_2012_4				
Comment Code					
DE : Debris					
Inspector Comment					
Bell Marine, LMA sent a letter to the property owner for this violation.

View of the debris stored in floodway.

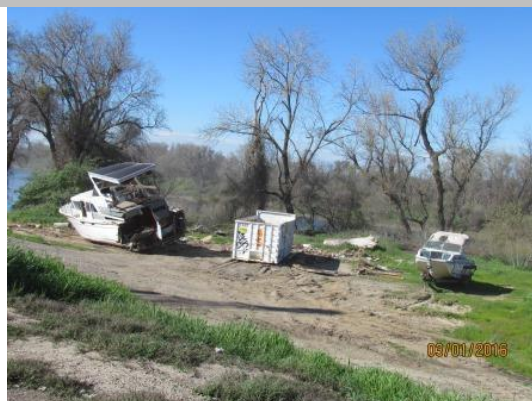
Photo 2 of 2 : FA_2016_NA0001_55_4_20160914_00005.jpg

View of the derelict boats in the floodway. Bell Marine has a service contract to dispose of abandoned boats for the City.

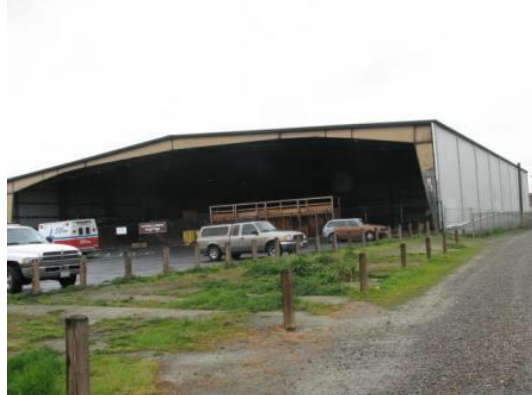
Photo 1 of 1 : FA_2016_NA0001_55_5_20160914_00006.jpg

LM Start	2.92	Rating **	U	Issue No.	5
LM End	2.96	Issue Type +	En	Location *	LS
Category	Earthen Levee			GPS Latitude/Longitude	
				Start	End
Item	Encroachments			38.587251 °	38.587318 °
				-121.463237 °	-121.462513 °
DWR ID	DWR_NA0001_04_s_2012_5				
Comment Code					
BU : Building					
Inspector Comment					
City of Sacramento building. Building is now Sutter's Landing Skate Park.

03/16/2012 Sutter's Landing Skate Park.

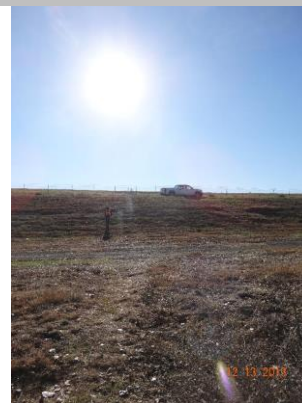
Photo 1 of 2 : UCIP_FA_2016_31254_57217.jpg

Comment Code					
Inspector Comment					
FS_ID:31254					
DS_ID:24330					
EP_NO: 15041					
Repair Type: Non-Urgent					
Crossing Status: Indicator Found					
UCIP Comments: Hole present on riser located on landward side--contact owner. Additional pipe found in waterward berm. Unable to confirm if this pipe section is part of crossing--size does not match. Unable to find CM standpipe on waterward side.					
FIELD_STRUCT_DESC: 16-inch corrugated metal (CM) drainpipe through the levee. Steel cutoff wall around pipe at center of levee.					
Storm drain gate on landside (LS) shoulder. Drainage ditch on LS. CM standpipe on WS. Rock-filled ditch on WS. (Permit No. 15041-1993)					
FS Date: 12/13/2013

Overview of waterward side.

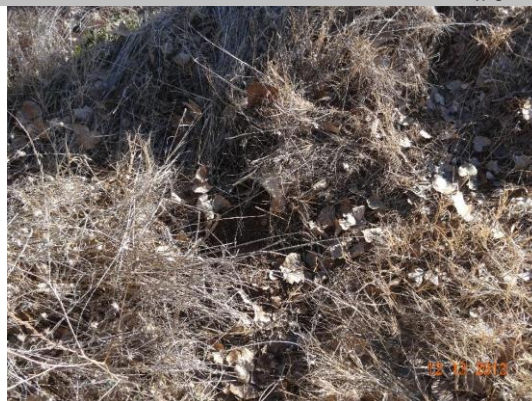
Photo 2 of 2 : UCIP_FA_2016_31254_57219.jpg

Pipe buried by vegetation--unable to determine if pipe goes through levee.

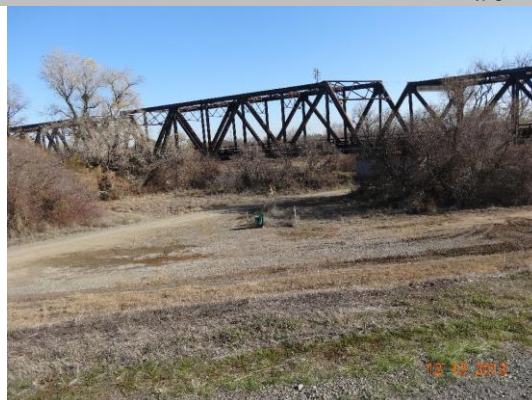
Photo 1 of 2 : UCIP_FA_2016_42128_56573.jpg

Comment Code					
Inspector Comment					
FS_ID:42128 DS_ID:24807 EP_NO: N/A Repair Type: Non-Urgent Crossing Status: Indicator Found UCIP Comments: 11/3/2014 (DWR-Olivia) Need to contact owner to determine status of crossing. Priority under Part IX has been changed from Urgent to Non-Urgent as a measure to normalize the data. Per Title 23 markers are necessary for pressure line--markers present. Recommend LMA to contact owner to determine additional information details--CVFPB permit, depth of pipe through levee, alignment, and last inspection completed confirming integrity of crossing.No permit found. Will need to contact owner to determine the status of crossing. FIELD_STRUCT_DESC: Petroleum pipeline through the levee, unknow depth. Markers visible on waterside (WS). Unable to confirm alignment. Kinder Morgan (Owner) contact information is 916-363-1666. FS Date: 12/13/2013

View of waterward side.

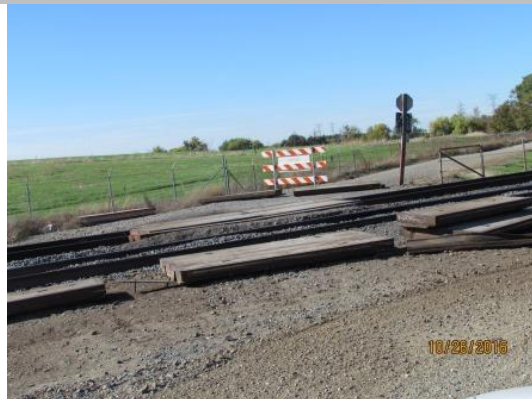
Photo 1 of 1 : FA_2016_NA0001_55_251_20161031_00251.jpg

LM Start	3.71	Rating **	U	Issue No.	251
LM End	3.71	Issue Type +	En	Location *	CR
Category	Earthen Levee			GPS Latitude/Longitude	
				Start	End
Item	Encroachments			38.588076 °	38.588076 °
				-121.450175 °	-121.450175 °
DWR ID	DWR_NA0001_04_f_2016_251				
Comment Code					
MA : Material					
Inspector Comment					
UPRR removed crossing. Unable to cross the tracks during high water.

View of the removed RR crossing on the crown.

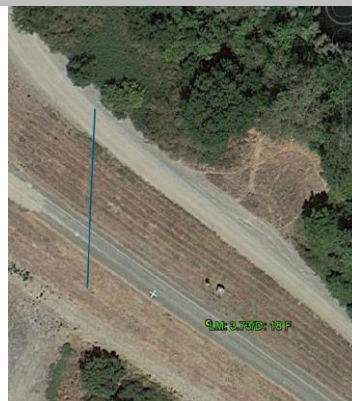
Photo 1 of 2 : UCIP_FA_2016_31255_57226.jpg

LM Start	3.75	Rating **	M	Issue No.	768
LM End	3.75	Issue Type +	En	Location *	CR
Category	Supplemental			GPS Latitude/Longitude	
				Start	End
Item	DWR UCIP Field Study			38.587724 °	38.587724 °
				-121.449554 °	-121.449554 °
DWR ID					
Comment Code					
Inspector Comment					
FS_ID:31255					
DS_ID:24335					
EP_NO: N/A					
Repair Type: Non-Urgent					
Crossing Status: Found					
UCIP Comments: Control box is non-functional parts have been removed. Unable to confirm diameter size and status--City of Sacramento indicates a 24 inch sewer main not 18 inch. Need to contact owner to confirm size.					
FIELD_STRUCT_DESC: 18-inch sewer main through the levee.					
Concrete manhole on the waterside (WS) slope.					
FS Date: 12/13/2013

Approximate alignment provided by City of Sacramento and DWR-UCIP confirmed location of sewer line is indicated by green label.

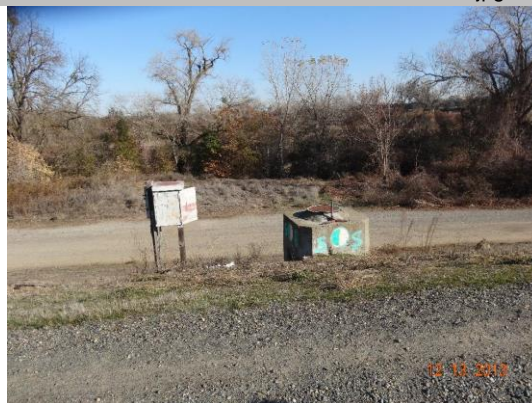
Photo 2 of 2 : UCIP_FA_2016_31255_57223.jpg

View of waterward side.

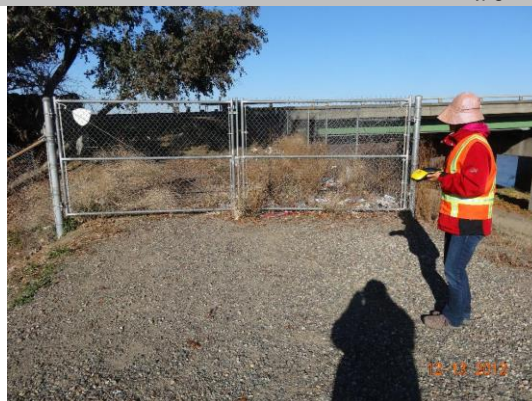
Photo 1 of 2 : UCIP_FA_2016_50051_55292.jpg

FS_ID:50051
DS_ID:24311
EP_NO: 2805
Repair Type: Urgent
Crossing Status: Indicator Found
UCIP Comments: 8/11/2016 Inspected the crossing with Tim Kerr and Richard Marck, LMA representatives, and it appears that this crossing is not the correct location. The odor could be due to a sewer clean out located on LS toe. Need to do additional research and coordinate with Sacramento County to confirm crossing location. (DWR UCIP - omagana)12/19/2016 bad odor (sewage smell) coming from this area -- potential leak. Unable to confirm if riser on landward side is part of crossing. (DWR UCIP - omagana)
FIELD_STRUCT_DESC: [Co Sanitation District No. 2 Pump Station] 18-inch concrete sewer main through the levee, 9.0 feet below the crown. Concrete cutoff wall around pipe located under waterside (WS) shoulder. 2-inch air release valve located on landside (LS) slope. Sewage pumping plant on LS. Rock revetment on WS slope. Crossing continues under the channel and through the opposite levee. (Permit No. 2805, 1961 - Sacramento County Sanitation District No. 2)

View of levee crown section near highway.

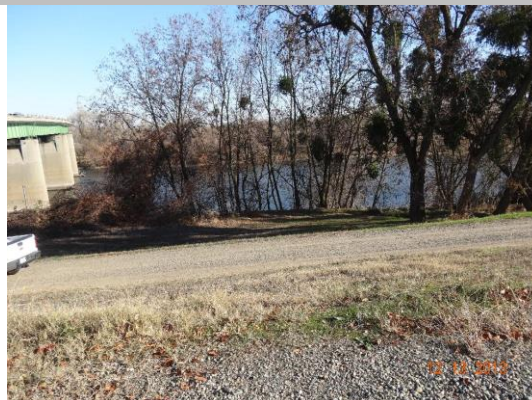
Photo 2 of 2 : UCIP_FA_2016_50051_55291.jpg

View of waterward side.

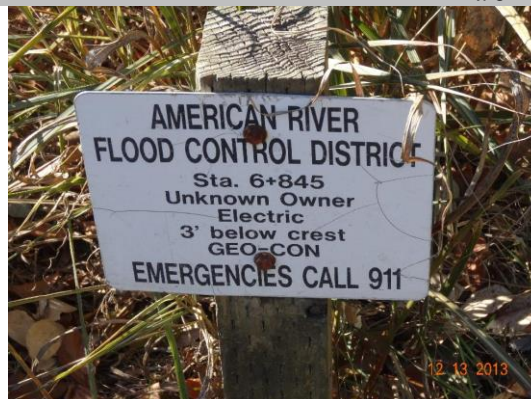
Photo 1 of 2 : UCIP_FA_2016_29054_53588.jpg

LM Start	3.89	Rating **	M	Issue No.	755
LM End	3.89	Issue Type +	En	Location *	CR
Category	Supplemental			GPS Latitude/Longitude	
				Start	End
Item	DWR UCIP Field Study			38.586479 °	38.586479 °
				-121.447574 °	-121.447574 °
DWR ID					
Comment Code					
Inspector Comment					
FS_ID:29054					
DS_ID:24337					
EP_NO: N/A					
Repair Type: Non-Urgent					
Crossing Status: Found					
UCIP Comments: Unknown owner--Need to coordinate with DWR Inspector and CVFPB.					
FIELD_STRUCT_DESC: 3-inch PVC conduit through levee, 2.0 feet below the crown.					
FS Date: 12/13/2013

Electrical conduit marker located on landward toe.

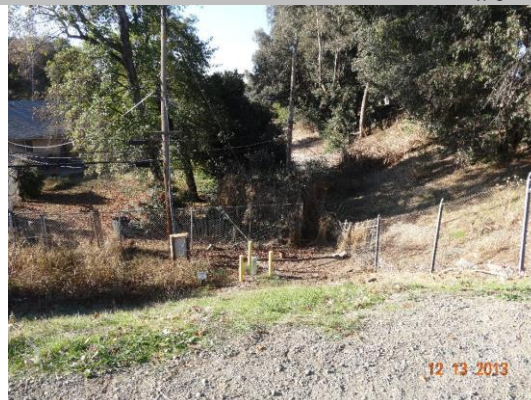
Photo 2 of 2 : UCIP_FA_2016_29054_53587.jpg

View of landward side.

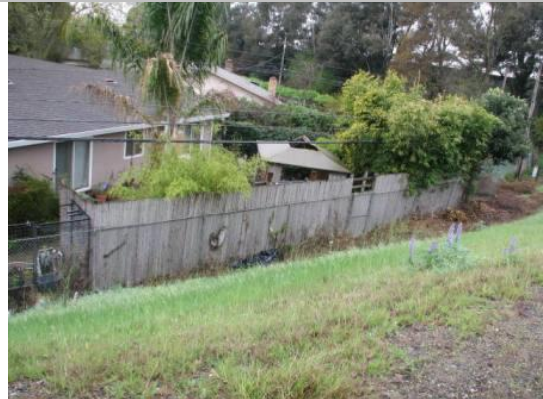
Photo 1 of 2 : FA_2016_NA0001_55_8_20160914_00009.jpg

03/16/2012 Wood privacy fence completely obstructs access and visibility.

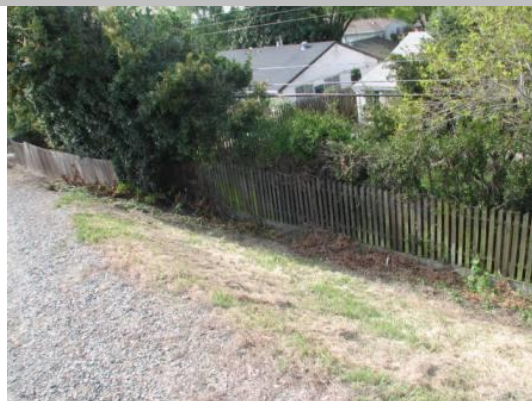
Photo 1 of 1 : FA_2016_NA0001_55_6_20160914_00007.jpg

LM Start	3.92	Rating **	U	Issue No.	6
LM End	3.92	Issue Type +	En	Location *	LS
Category	Earthen Levee			GPS Latitude/Longitude	
				Start	End
Item	Encroachments			38.586154 °	38.586154 °
				-121.447115 °	-121.447115 °
DWR ID	DWR_NA0001_04_s_2012_6				
Comment Code					
FE : Fence					
Inspector Comment					
Privacy fence within 10-ft of the landside toe obstructs visibility. 04/14/2011 Landscaping has been removed.

04/14/2011 Landscaping, which was a Fall inspection issue has been removed, however wooden fence is still obstructing access and visibility.

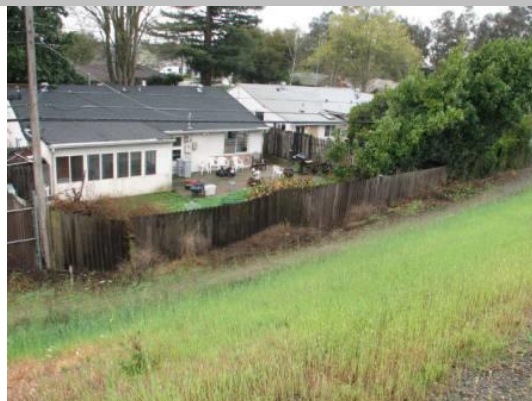
Photo 1 of 1 : FA_2016_NA0001_55_9_20160914_00011.jpg

LM Start	3.93	Rating **	U	Issue No.	9
LM End	3.93	Issue Type +	En	Location *	LS
Category	Earthen Levee			GPS Latitude/Longitude	
				Start	End
Item	Encroachments			38.586047 °	38.586047 °
				-121.446975 °	-121.446975 °
DWR ID	DWR_NA0001_04_s_2012_9				
Comment Code					
FE : Fence					
Inspector Comment					
Wooden privacy fence on the levee slope obstructs access and visibility.

03/16/2012 Wood privacy fence completely obstructs access and visibility.

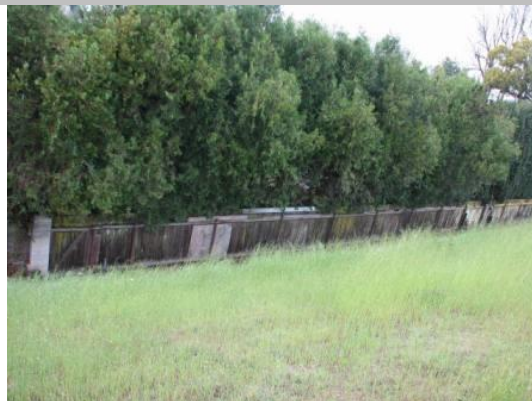
Photo 1 of 1 : FA_2016_NA0001_55_15_20160914_00016.jpg

LM Start	4.03	Rating **	U	Issue No.	15
LM End	4.03	Issue Type +	En	Location *	LS
Category	Earthen Levee			GPS Latitude/Longitude	
				Start	End
Item	Encroachments			38.585021°	38.585021°
				-121.445678°	-121.445678°
DWR ID	DWR_NA0001_04_s_2012_15				
Comment Code					
FE : Fence					
Inspector Comment					
Privacy fence and evergreen shrub landscaping within 10-ft of the levee toe obstruct access and visibility.

03/16/2012 Wood privacy fence completely obstructs access and visibility.

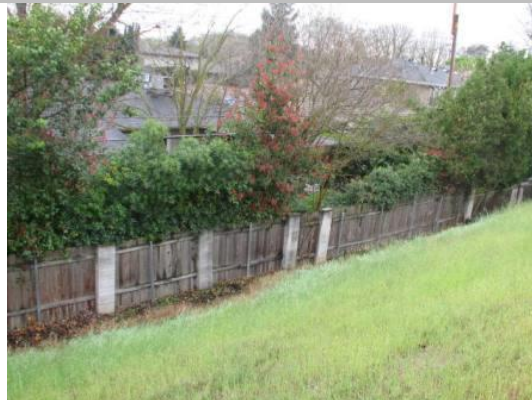
Photo 1 of 1 : FA_2016_NA0001_55_16_20160914_00017.jpg

LM Start	4.04	Rating **	U	Issue No.	16
LM End	4.04	Issue Type +	En	Location *	LS
Category	Earthen Levee			GPS Latitude/Longitude	
				Start	End
Item	Encroachments			38.584885 °	38.584885 °
				-121.445520 °	-121.445520 °
DWR ID	DWR_NA0001_04_s_2012_16				
Comment Code					
FE : Fence					
Inspector Comment					
Privacy fence and landscaping within 10-ft of the levee toe obstruct access and visibility.

03/16/2012 Wood privacy fence completely obstructs access and visibility.

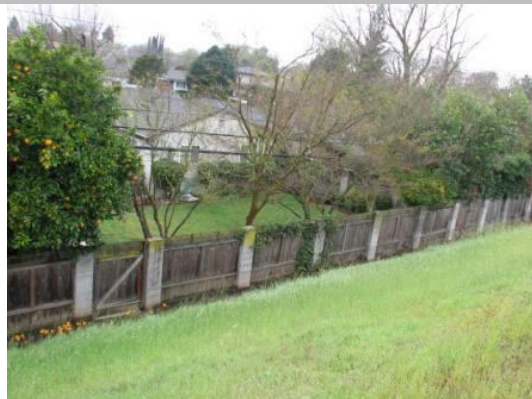
Photo 1 of 1 : FA_2016_NA0001_55_17_20160914_00018.jpg

LM Start	4.05	Rating **	U	Issue No.	17
LM End	4.05	Issue Type +	En	Location *	LS
Category	Earthen Levee			GPS Latitude/Longitude	
				Start	End
Item	Encroachments			38.584810 °	38.584810 °
				-121.445403 °	-121.445403 °
DWR ID	DWR_NA0001_04_s_2012_17				
Comment Code					
FE : Fence					
Inspector Comment					
Privacy fence and maple tree landscaping within 10-ft of the levee toe obstruct access and visibility.

03/16/2012 Wood privacy fence completely obstructs access and visibility.

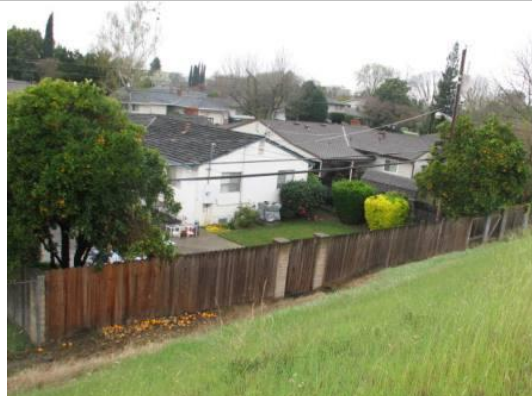
Photo 1 of 1 : FA_2016_NA0001_55_18_20160914_00019.jpg

LM Start	4.06	Rating **	U	Issue No.	18
LM End	4.06	Issue Type +	En	Location *	LS
Category	Earthen Levee			GPS Latitude/Longitude	
				Start	End
Item	Encroachments			38.584694 °	38.584694 °
				-121.445255 °	-121.445255 °
DWR ID	DWR_NA0001_04_s_2012_18				
Comment Code					
FE : Fence					
Inspector Comment					
Wooden fence between orange trees is within 10-ft of the levee toe.

03/16/2012 Wood privacy fence completely obstructs access and visibility.

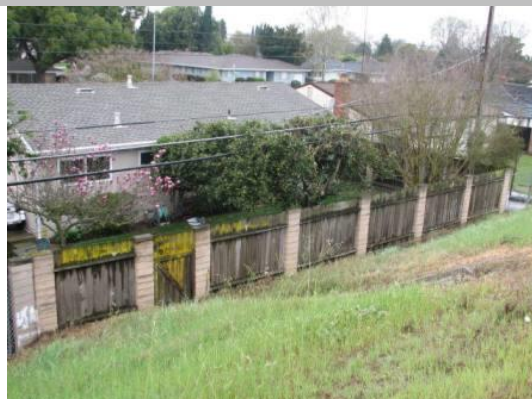
Photo 1 of 1 : FA_2016_NA0001_55_19_20160914_00020.jpg

LM Start	4.09	Rating **	U	Issue No.	19
LM End	4.09	Issue Type +	En	Location *	LS
Category	Earthen Levee			GPS Latitude/Longitude	
				Start	End
Item	Encroachments			38.584459 °	38.584459 °
				-121.444951 °	-121.444951 °
DWR ID	DWR_NA0001_04_s_2012_19				
Comment Code					
FE : Fence					
Inspector Comment					
Privacy fence within 10-ft of the levee toe obstruct access and visibility.

03/16/2012 Wood privacy fence completely obstructs access and visibility.

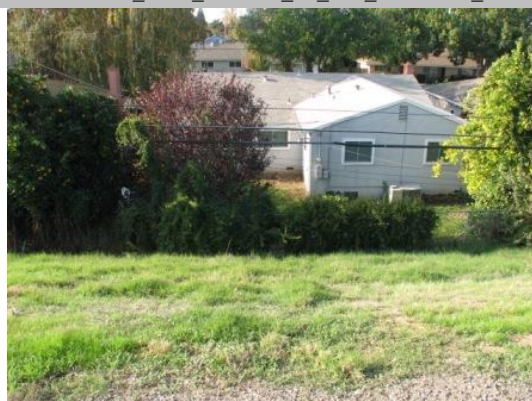
Photo 1 of 1 : FA_2016_NA0001_55_186_20160914_00160.jpg

LM Start	4.10	Rating **	M	Issue No.	186
LM End	4.10	Issue Type +	En	Location *	LS
Category	Earthen Levee			GPS Latitude/Longitude	
				Start	End
Item	Vegetation			38.584354 °	38.584354 °
				-121.444792 °	-121.444792 °
DWR ID	DWR_NA0001_04_s_2012_186				
Comment Code					
V6 : Landscaping					
Inspector Comment					
Landscaping on cyclone fence within 10-ft of levee toe obstructs access and visibility.

Fall 2009 photo: Landscaping within 10-ft of levee toe obstructs access and visibility.

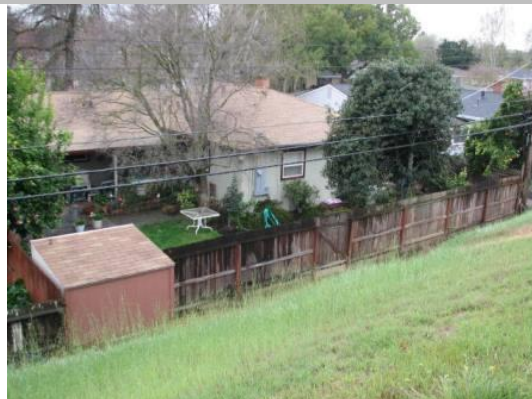
Photo 1 of 1 : FA_2016_NA0001_55_20_20160914_00021.jpg

LM Start	4.11	Rating **	U	Issue No.	20
LM End	4.11	Issue Type +	En	Location *	LS
Category	Earthen Levee			GPS Latitude/Longitude	
				Start	End
Item	Encroachments			38.584243 °	38.584243 °
				-121.444647 °	-121.444647 °
DWR ID	DWR_NA0001_04_s_2012_20				
Comment Code					
FE : Fence					
Inspector Comment					
Privacy fence and shed within 10-ft of the levee toe obstruct access and visibility.

03/16/2012 Wood privacy fence completely obstructs access and visibility.

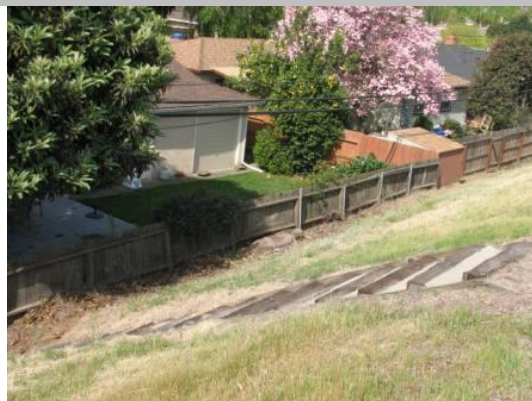
Photo 1 of 1 : FA_2016_NA0001_55_21_20160914_00022.jpg

LM Start	4.12	Rating **	U	Issue No.	21
LM End	4.12	Issue Type +	En	Location *	LS
Category	Earthen Levee			GPS Latitude/Longitude	
				Start	End
Item	Vegetation			38.584129 °	38.584129 °
				-121.444485 °	-121.444485 °
DWR ID	DWR_NA0001_04_s_2012_21				
Comment Code					
V6 : Landscaping					
Inspector Comment					
Palms and other landscaping on levee slope, as well as the wooden privacy fence within 10-ft of the levee toe obstruct access and visibility. 04/14/2011 Palms have been removed.

04/14/2011 Palms have been removed.

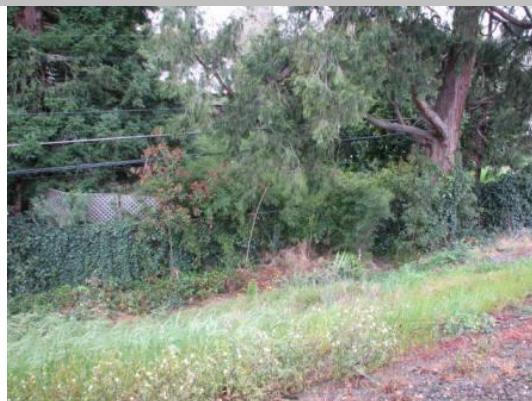
Photo 1 of 1 : FA_2016_NA0001_55_192_20160914_00164.jpg

LM Start	4.25	Rating **	U	Issue No.	192
LM End	4.25	Issue Type +	En	Location *	LS
Category	Earthen Levee			GPS Latitude/Longitude	
				Start	End
Item	Vegetation			38.583031 °	38.583031 °
				-121.442620 °	-121.442620 °
DWR ID	DWR_NA0001_04_s _ 2012_192				
Comment Code					
V6 : Landscaping					
Inspector Comment					
Ivy and vine growth on cyclone fence obstruct visibility. Steps and landscaping built up levee slope.

03/16/2012 Landscaping on fence obstructs visibility and access.

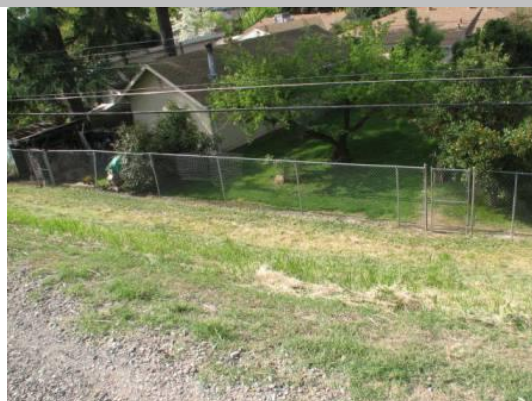
Photo 1 of 1 : FA_2016_NA0001_55_194_20160914_00165.jpg

LM Start	4.28	Rating **	M	Issue No.	194
LM End	4.28	Issue Type +	En	Location *	LS
Category	Earthen Levee			GPS Latitude/Longitude	
				Start	End
Item	Encroachments			38.582716 °	38.582716 °
				-121.442128 °	-121.442128 °
DWR ID	DWR_NA0001_04_s _ 2012_194				
Comment Code					
FE : Fence					
Inspector Comment					
Planting boxes built into levee slope. 04/14/2011 Planter boxes removed. Chainlink fence partially obstructs access.

04/14/2011 Planter boxes have been removed. Chainlink fence partially blocks access.

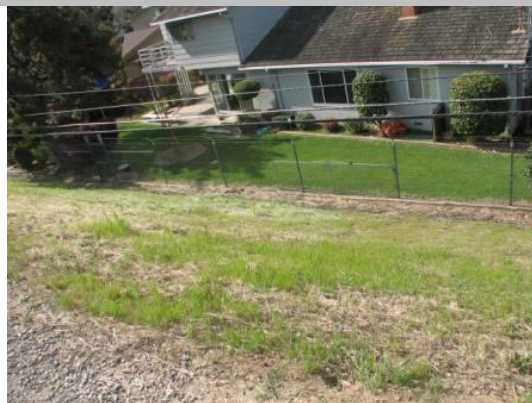
Photo 1 of 1 : FA_2016_NA0001_55_195_20160914_00166.jpg

LM Start	4.32	Rating **	M	Issue No.	195
LM End	4.32	Issue Type +	En	Location *	LS
Category	Earthen Levee			GPS Latitude/Longitude	
				Start	End
Item	Encroachments			38.582333 °	38.582333 °
				-121.441506 °	-121.441506 °
DWR ID	DWR_NA0001_04_s_2012_195				
Comment Code					
FE : Fence					
Inspector Comment					
Landscaping planted on levee slope. 04/14/2011 Landscaping removed, chainlink fence remains.

04/14/2011 Landscape removed, chainlink fence remains.

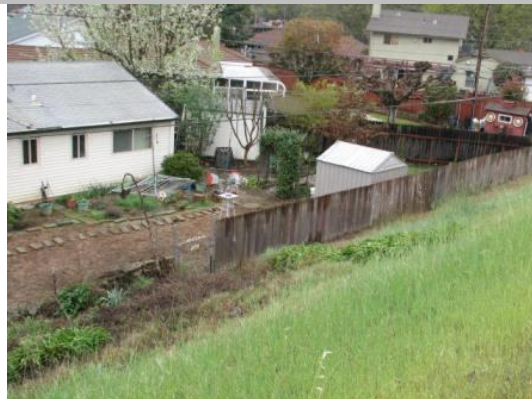
Photo 1 of 1 : FA_2016_NA0001_55_29_20160914_00029.jpg

LM Start	4.36	Rating **	M	Issue No.	29
LM End	4.36	Issue Type +	En	Location *	LS
Category	Earthen Levee			GPS Latitude/Longitude	
				Start	End
Item	Encroachments			38.582083 °	38.582083 °
				-121.440875 °	-121.440875 °
DWR ID	DWR_NA0001_04_s_2012_29				
Comment Code					
FE : Fence					
Inspector Comment					
Large flowering bush on levee slope - removed by ARFCD 2012. Retaining wall removed by ARFCD 2012. Wooden fence located at the levee toe obstructs access and visibility. 04/14/2011

03/16/2012 Flowering bush is dormant, landscaping on levee slope and wooden privacy fence.

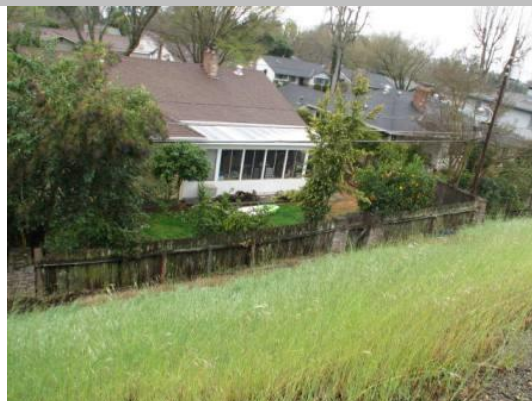
Photo 1 of 1 : FA_2016_NA0001_55_30_20160914_00030.jpg

LM Start	4.42	Rating **	U	Issue No.	30
LM End	4.42	Issue Type +	En	Location *	LS
Category	Earthen Levee			GPS Latitude/Longitude	
				Start	End
Item	Encroachments			38.581724 °	38.581724 °
				-121.439891 °	-121.439891 °
DWR ID	DWR_NA0001_04_s_2012_30				
Comment Code					
FE : Fence					
Inspector Comment					
Privacy fence and landscaping within 10-ft of the levee toe obstruct access and visibility.

03/16/2012 Wood privacy fence completely obstructs access and visibility.

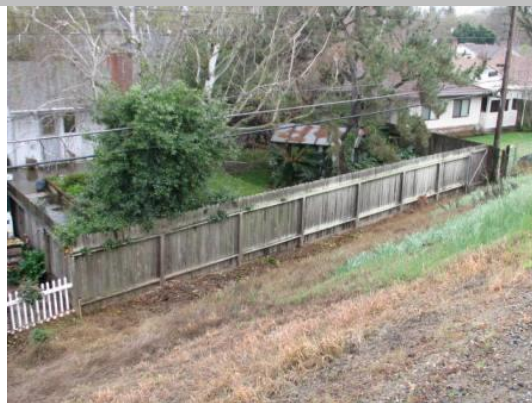
Photo 1 of 1 : FA_2016_NA0001_55_31_20160914_00031.jpg

LM Start	4.47	Rating **	U	Issue No.	31
LM End	4.47	Issue Type +	En	Location *	LS
Category	Earthen Levee			GPS Latitude/Longitude	
				Start	End
Item	Encroachments			38.581495 °	38.581495 °
				-121.439129 °	-121.439129 °
DWR ID	DWR_NA0001_04_s_2012_31				
Comment Code					
FE : Fence					
Inspector Comment					
Privacy fence within 10-ft of the levee toe obstructs access and visibility.

03/16/2012 Wood privacy fence completely obstructs access and visibility.

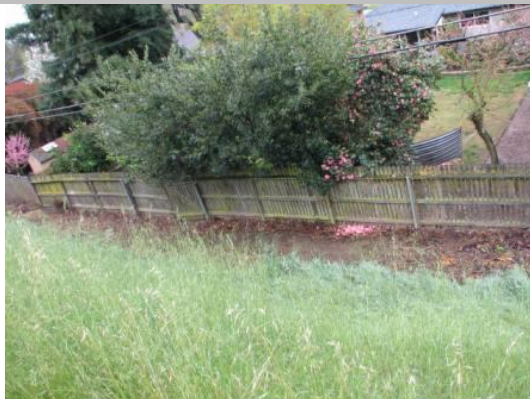
Photo 1 of 1 : FA_2016_NA0001_55_201_20160914_00171.jpg

LM Start	4.57	Rating **	U	Issue No.	201
LM End	4.57	Issue Type +	En	Location *	LS
Category	Earthen Levee			GPS Latitude/Longitude	
				Start	End
Item	Encroachments			38.581155 °	38.581155 °
				-121.437320 °	-121.437320 °
DWR ID	DWR_NA0001_04_s_2012_201				
Comment Code					
FE : Fence					
Inspector Comment					
Privacy fence within 10-ft of the levee toe obstruct access and visibility.

03/16/2012 Wood privacy fence completely obstructs access and visibility.
